Precinct: Mates' Housing
Development Precinct

Address: 3 –5 Miller Street and 1060 – 1070 Whitehorse Road **Melway Map Ref:** 47 E9

Building Type: Houses & former Dairy **Construction Date** 1912 - 1913

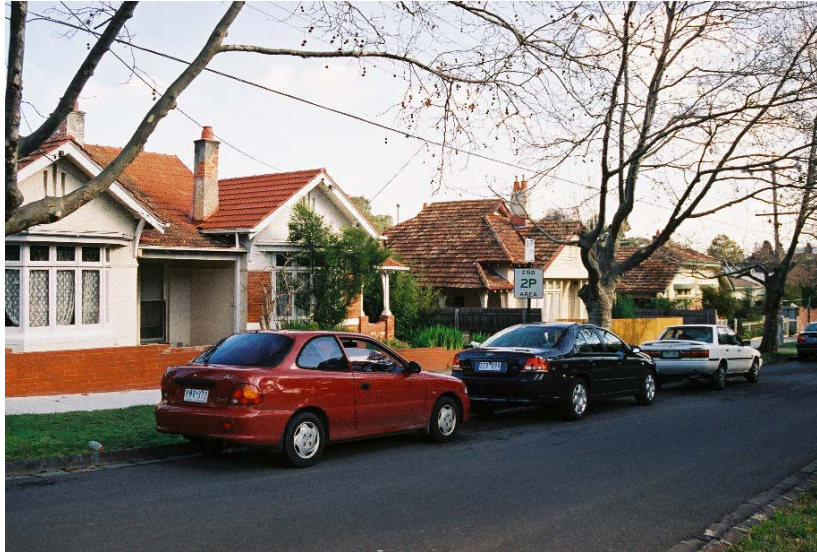
From left to right – 1070, 1068, 1066, 1064, 1062 & 1060 Whitehorse Road

All of the houses in this complex (eight dwellings) were constructed at the same time and by the same developer and have similar forms and details. Each house is a mirror image of its attached pair with the exception of 1070 and 1068 Whitehorse Road. Overall the form and design elements are similar with a subtle variation on particular elements for each pair. For example, while all houses have decorative gable ends and bay windows in similar locations, the gable end form and decoration varies for each pair, as does the form of the bay windows. The combination of roof forms varies, however all houses have complex roof forms at the front clad in terracotta tiles and simple roofs at the end clad in corrugated iron. The exception to this is 1070 Whitehorse Road which has the entire roof clad in terracotta tiles. The porch entry is in the same location for seven of the eight dwellings, the exception being 1070 Whitehorse Road.

Numbers 1060 (Mantua) and 1062 (Medina) Whitehorse Road are semi-detached brick Federation dwellings. The front of the houses include two thirds of a gambrel roof. Behind this is a gable wing perpendicular to the gambrel roof. There is a side porch at the front extending between the gable wing and the front of the house with a skillion roof that continues from the main roof. The rear section of the houses is half of a hip roof shared between the attached properties. The roof at the front including the gable, gambrel and porch roof is clad in terracotta tiles, while the roof at the rear is clad in corrugated iron. The front room has a bow window to the Whitehorse Road elevation with timber framed casement windows and a curved canopy over. There is a box bay window further down the side elevation. The front gable end is clad in weatherboards with two central louvre vents. On the elevation facing Whitehorse Road there is a rough stucco band between the eaves and the base of the highlight windows in the bow window. The remainder of the residence is face red brick. The porch has brick posts with curved timber brackets and a brick balustrade in between. The porch ends facing Whitehorse Road are clad in weatherboards. Entry to the house is via this side porch. There is a central double flue chimney towards the front of the property shared between the two attached houses. The brick chimney has terracotta chimney pots. It is likely that this chimney previously had a stucco finish. The property has a hairpin wire fence a side path entry with a hairpin wire gate set in from the front footpath.

Numbers 1064 (Marmora) and 1066 (Macedonia) are semi-detached brick Federation dwellings. The houses includes a front gable shared by the attached houses extending to the end of the bay windows. Behind this is a hip roof over both dwellings and a gable wing behind this and perpendicular to the hip roof. It has a side porch at the front extending between the gables with a hipped roof that partly continues from the main roof. The roof at the front

Unlike the other semi-detached houses in this development the two houses at 1070 (Moldavia) and 1068 (Maloja) Whitehorse Road are not mirror images of each other. The residence at 1068 Whitehorse Road is similar in form to 5 Miller Street.
